## **Technical Specifications**

Fiber Reinforcement: FORTA-FI®

**Application:** Resurfacing Mix Design: PG 64-22 Overlay Thickness: 4.5"

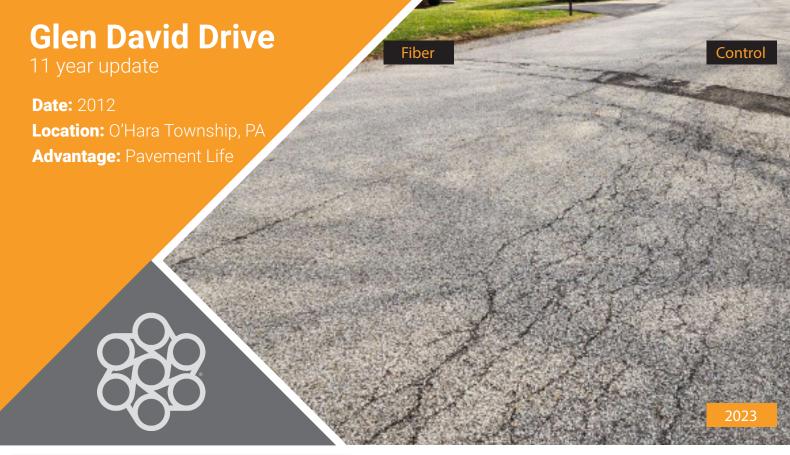
The FORTAfied® asphalt shows minimal signs of cracking after 11 years of wear and tear. FORTA-FI's ability to hold the asphalt matrix is evident. The lighter color of the FORTA-FI asphalt shows that the reinforcement fiber is more adequately holding the asphalt fines together. This is also apparent by the visible pothole where the speed bump was removed on the control side. Although the fiber side shows some deterioration, it remains intact.

Township engineers were looking to extend the life of this heavily cracked cul-de-sac while reducing reflective and alligator cracking. This control vs. fiber project consists of one lane with a 3" intermediate course and a 1 ½" wearing course without fiber, while the other lane uses FORTAfied® asphalt for both layers.
